Stresses in the Web Reinforcement  
of Restrained Concrete Beams

**STRESSES IN THE WEB REINFORCEMENT OF RESTRAINED  
CONCRETE BEAMS**

**THESIS**

**IN THEORETICAL AND APPLIED MECHANICS**

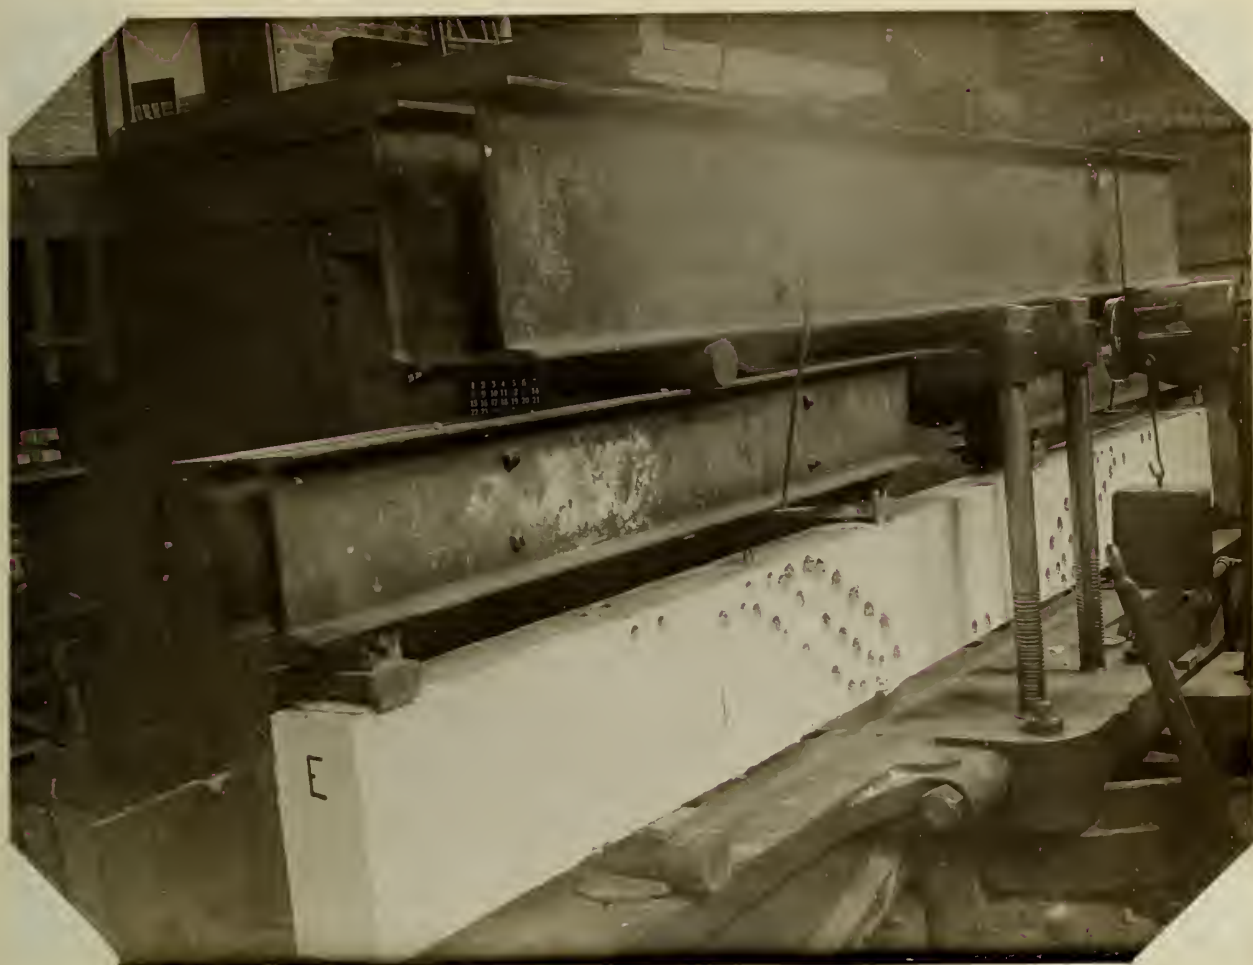
Fig. 2.  
View of beam in machine ready for test.

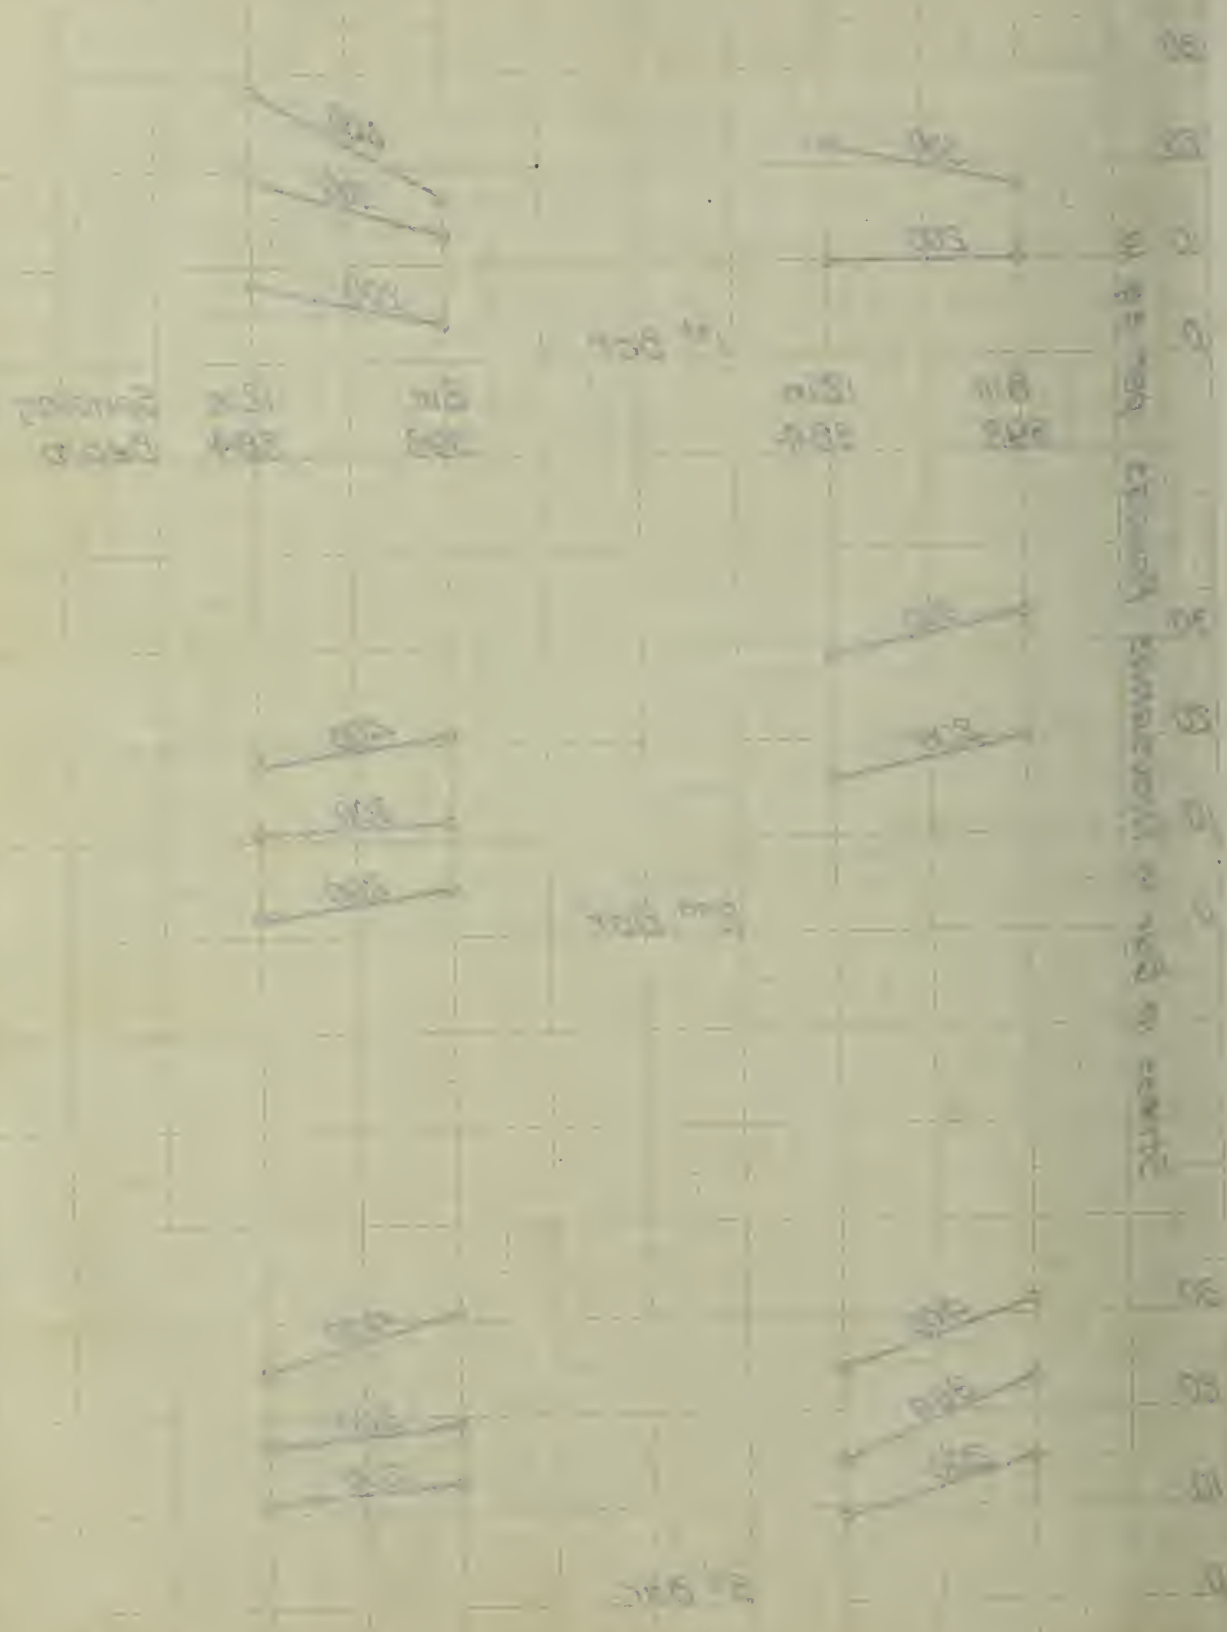
# Effect of Distance from Support to First Bend.
